**NASA TECHNICAL MEMORANDUM 107620**

**ENVIRONMENTAL FATIGUE OF AN Al-Li-Cu  
ALLOY: PART II - MICROSCOPIC HYDROGEN  
CRACKING PROCESSES**

**Robert S. Piascik and Richard P. Gangloff**

**MAY 1992**

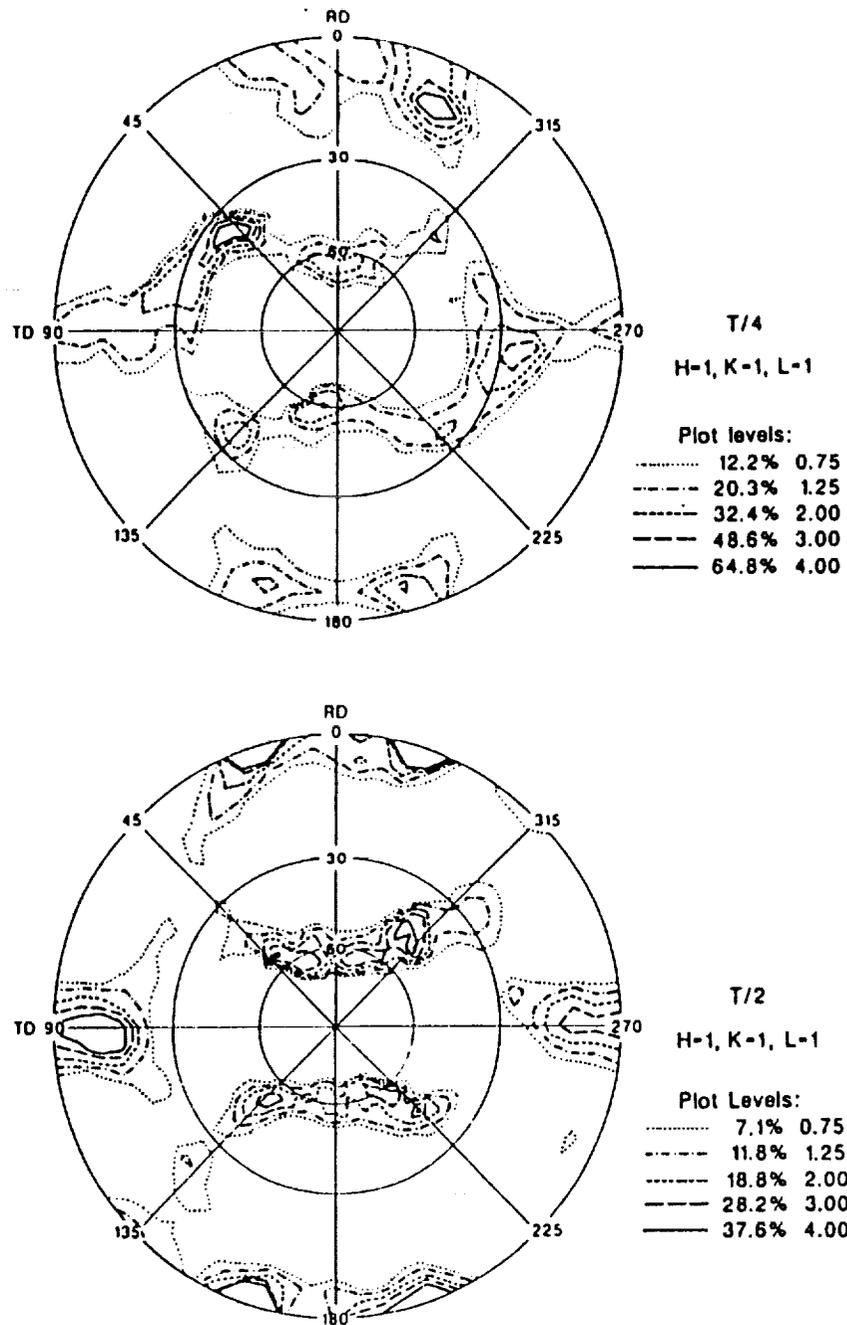
*Figure 1* Crystallographic texture of 2090 represented by {111} pole figures at two plate locations; (a) T/4 thickness and (b) T/2 thickness. (RD = rolling direction (longitudinal); TD = transverse direction.)

X-ray texture analysis of the 38 mm thick 2090 plate at the T/4 and T/2 thickness positions confirms the lack of recrystallization.  $\{111\}$  pole figures are shown in Figure 1. These results indicate two components of the fcc "brass" deformation texture,  $\{110\} \langle 112 \rangle$ , at the T/2 location.<sup>3</sup> A cube texture,  $\{100\} \langle 001 \rangle$ , typical of recrystallization is not evident at the T/2 location, consistent with optical and electron microscopy. At the T/4 location, the deformation texture is present, but is less well defined and some recrystallization cube texture may be present. Interpretation of the texture in Figure 1 is complicated by the presence of the  $\{112\} \langle 111 \rangle$  and  $\{123\} \langle 412 \rangle$  components, particularly at the T/4 location. These results are consistent with the alloy 2090 texture reported by Yoder et al.<sup>(28,30)</sup>. Single edge crack fatigue specimens were machined about the T/3 location<sup>(3)</sup>.

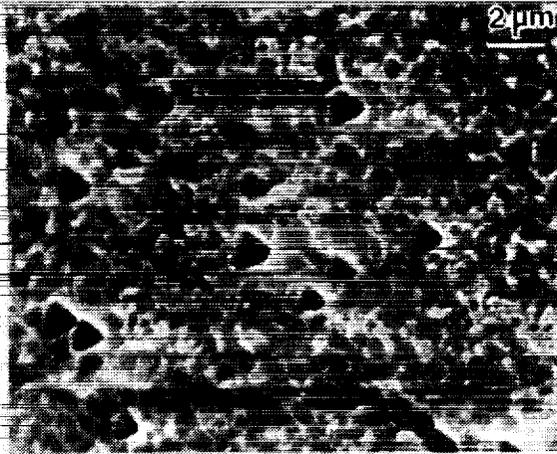
**Figure 5** SEM micrograph showing the etched crack surface of peak aged alloy 2090 (L-T) fatigue loaded in vacuum at  $\Delta K = 5 \text{ MPa}\sqrt{\text{m}}$  (5 Hz,  $R = 0.7$ ). The triangular pits indicate  $\{111\}$  slip plane cracking.

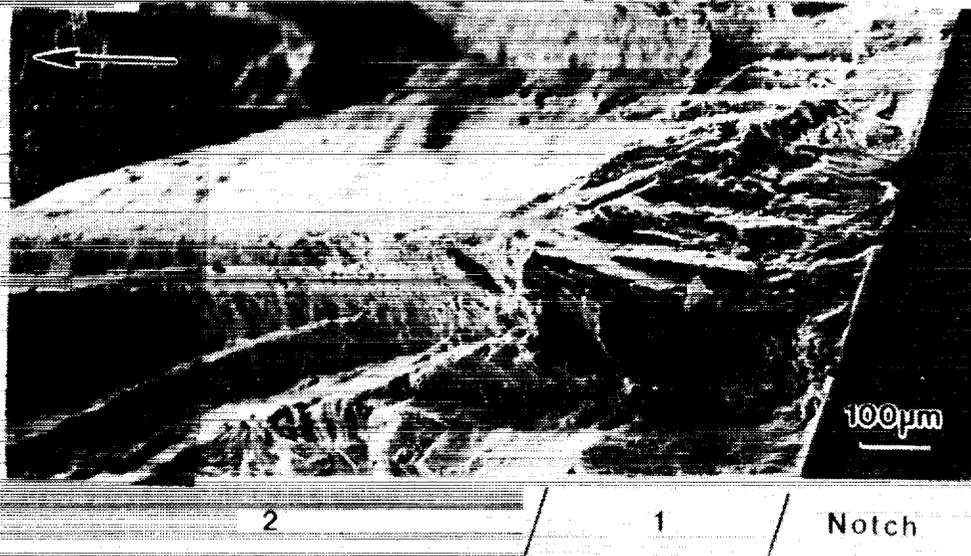
**Figure 6** SEM fractograph of the fatigue fracture surface of peak aged alloy 2090 (L-T) exposed to oxygen at  $f = 5 \text{ Hz}$ . Regions of constant  $\Delta K$  are shown; (1)  $10.6 \text{ MPa}\sqrt{\text{m}}$  ( $R = 0.05$ ) and (2)  $16.2 \text{ MPa}\sqrt{\text{m}}$  ( $R=0.05$ ).

**2. Oxygen:** The fatigue surfaces produced in oxygen at two constant  $\Delta K$  levels (10.6  $\text{MPa}\sqrt{\text{m}}$  and 16.2  $\text{MPa}\sqrt{\text{m}}$ ) exhibit a tortuous "twist" morphology similar to that observed for alloy 2090 in vacuum and helium, Figure 6. Etch pit analysis identified the planar asperity surfaces as parallel to  $\{111\}$  planes.

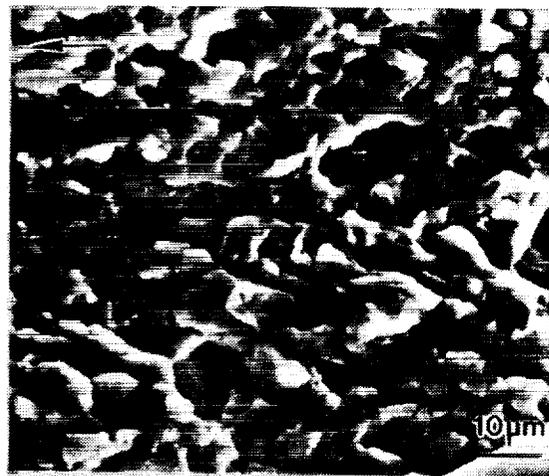
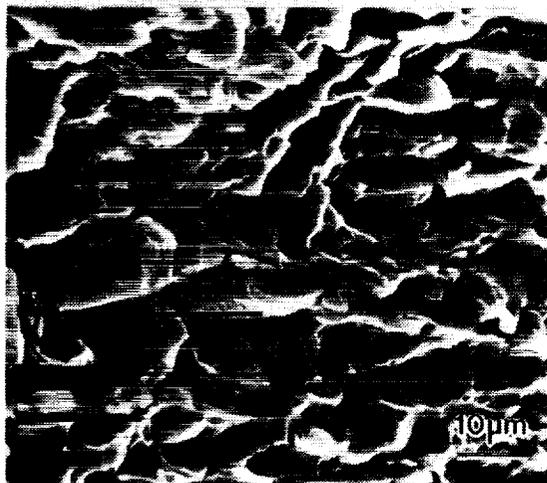
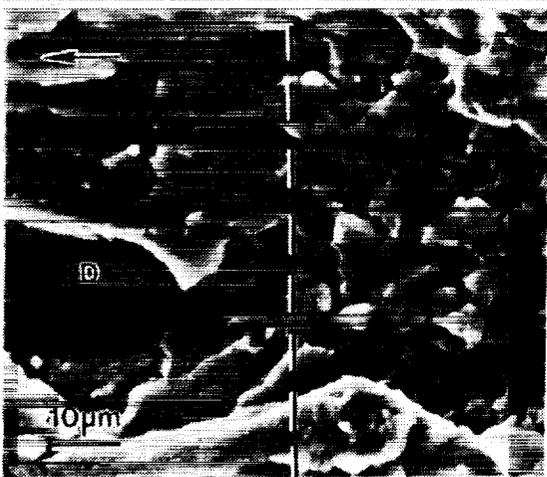
SEM fractographs showing detailed regions identified in Figure 7. (a) Region A; intersubgranular fatigue cracking in peak aged alloy 2090 (L-T) exposed to water vapor at  $16.2 \text{ MPa}\sqrt{\text{m}}$  ( $R = 0.05$ ), (b) Region C; SGC morphology of the monotonic overload fracture and (c) Region B; SGC to  $\{100\}$  cracking transition.

The regions outlined in Figure 4a include areas of subgrain boundary failure. The subgranular regions exhibit evidence of tearing, similar to that observed for tensile overload fracture (Figure 8b). Presumably, small ligaments of material remain between the fatigue slip plane cracks. These regions are not favorably oriented for SBC and fail along subgrain boundaries due to locally high tensile stress. Additionally, localized mechanical subgrain cracking may be due to a heterogeneous distribution of boundary  $T_1$ . Presumably, this phase governs intersubgranular microvoid fracture.

**1. Water Vapor:** FCP in saturation exposure water vapor<sup>(1)</sup> produces a flat crack surface, Figure 7, that exhibits different microscopic modes compared to tortuous SBC observed for the vacuum, helium and oxygen environments (Figures 4 and 6). At high  $\Delta K$  (16 MPa $\sqrt{m}$  and area A in Figure 7), the fatigue surface consists primarily of subgrain boundary cracking, Figure 8a. The features in this fractograph are similar in size to the subgrains observed by TEM, Figure 2a.

Intersubgranular fracture is produced in peak aged alloy 2090 by both fatigue in water vapor (Figure 8a) and overload tensile fracture (Figure 8b). It is speculated that  $T_1$  precipitates, concentrated along subgrain boundaries (Figure 2c), enhance environmentally induced subgranular fatigue fracture; possibly by trapping atomic hydrogen. Hydrogen enhanced subgranular fatigue crack surfaces are smooth, with no evidence of the tearing or dimpling that is observed in the overload region. Intersubgranular overload fracture is probably produced in this alloy because the higher aging temperature concentrated  $T_1$  precipitates along subgrain boundaries, and is unrelated to hydrogen embrittlement. Shorter aging times or lower peak aging temperatures produce a microstructure that fails by slip band overload fracture, rather than the subboundary mode<sup>(44)</sup>. The corrosion fatigue behavior of these heat treatments is not characterized.

For constant low  $\Delta K$  levels of 3.0 MPa $\sqrt{m}$  and 1.5 MPa $\sqrt{m}$  at high  $K_{max}$ , the environmental fatigue crack surface exhibits a flat crystallographic morphology, regions 2 and 3 in Figure 7. The dashed line in Figure 7 and the dashed line in the high magnification fractograph in Figure 8c show the high  $\Delta K$  (intersubgranular at 16.2 MPa $\sqrt{m}$ ) to low  $\Delta K$  (faceted cracking at 3.1 and 1.5 MPa $\sqrt{m}$ ) morphology transition. Etch pit analysis of the low  $\Delta K$  crystallographic regions reveals a square pit geometry (identical to that shown in Figure 10c for aqueous NaCl), indicating that cracking is crystallographic along {100} planes.

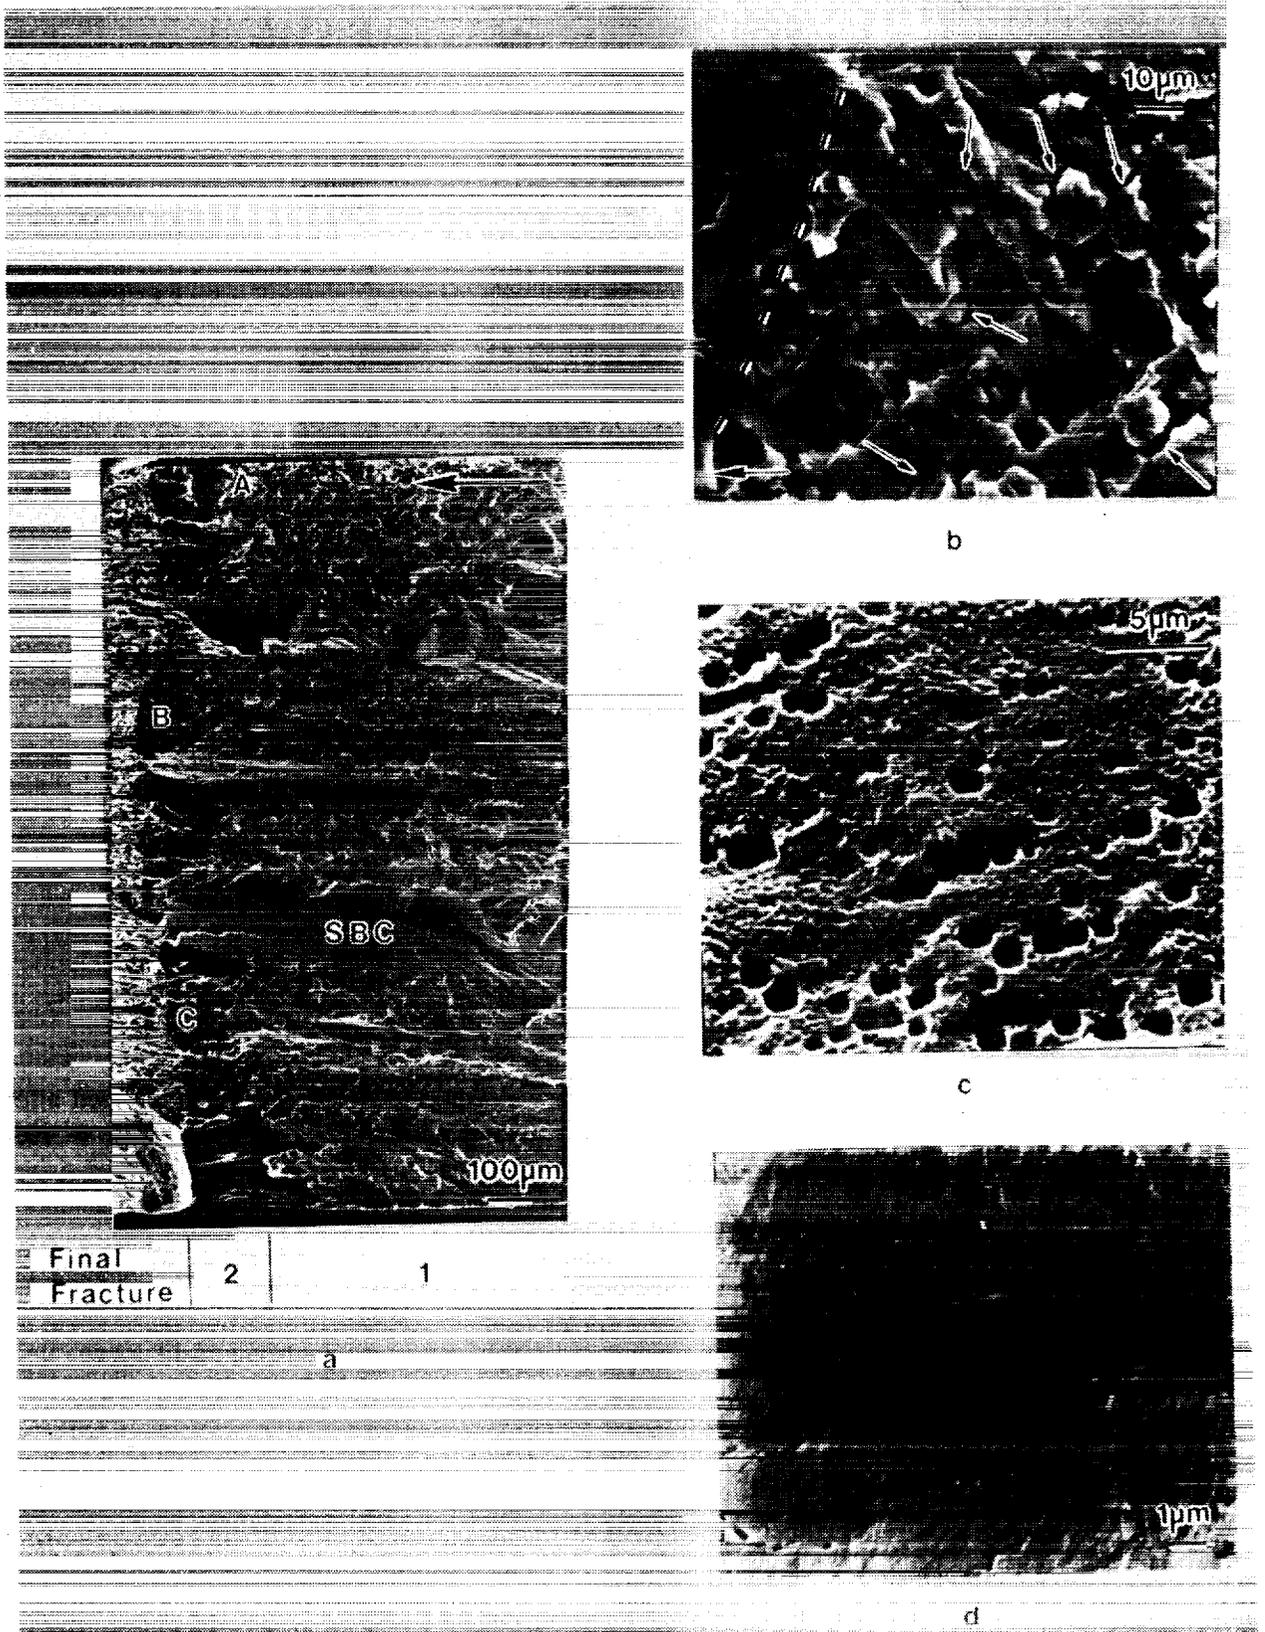
**Figure 10** (a) SEM fractograph of the fatigue crack surface in peak aged alloy 2090 (L-T) exposed to deaerated 1% NaCl ( $-840 \text{ mV}_{\text{SCE}}$ ) at 5 Hz. Regions of constant  $\Delta K$  are shown; (1)  $15.4 \text{ MPa}\sqrt{\text{m}}$  ( $R = 0.05$ ), (2)  $1.7 \text{ MPa}\sqrt{\text{m}}$  ( $R = 0.90$ ). (b) Dashed line divides the transition from SGC (right) at high  $\Delta K$  and  $\{100\}$  cracking (left) at low  $\Delta K$ . (c) Etched crystallographic fracture surface in Region B; the square pit geometry identifies the  $\{100\}$  fracture plane. (d) Crystallographic  $\{100\}$  fracture near the crack tip showing localized corrosion along subgrain boundaries in Region C.

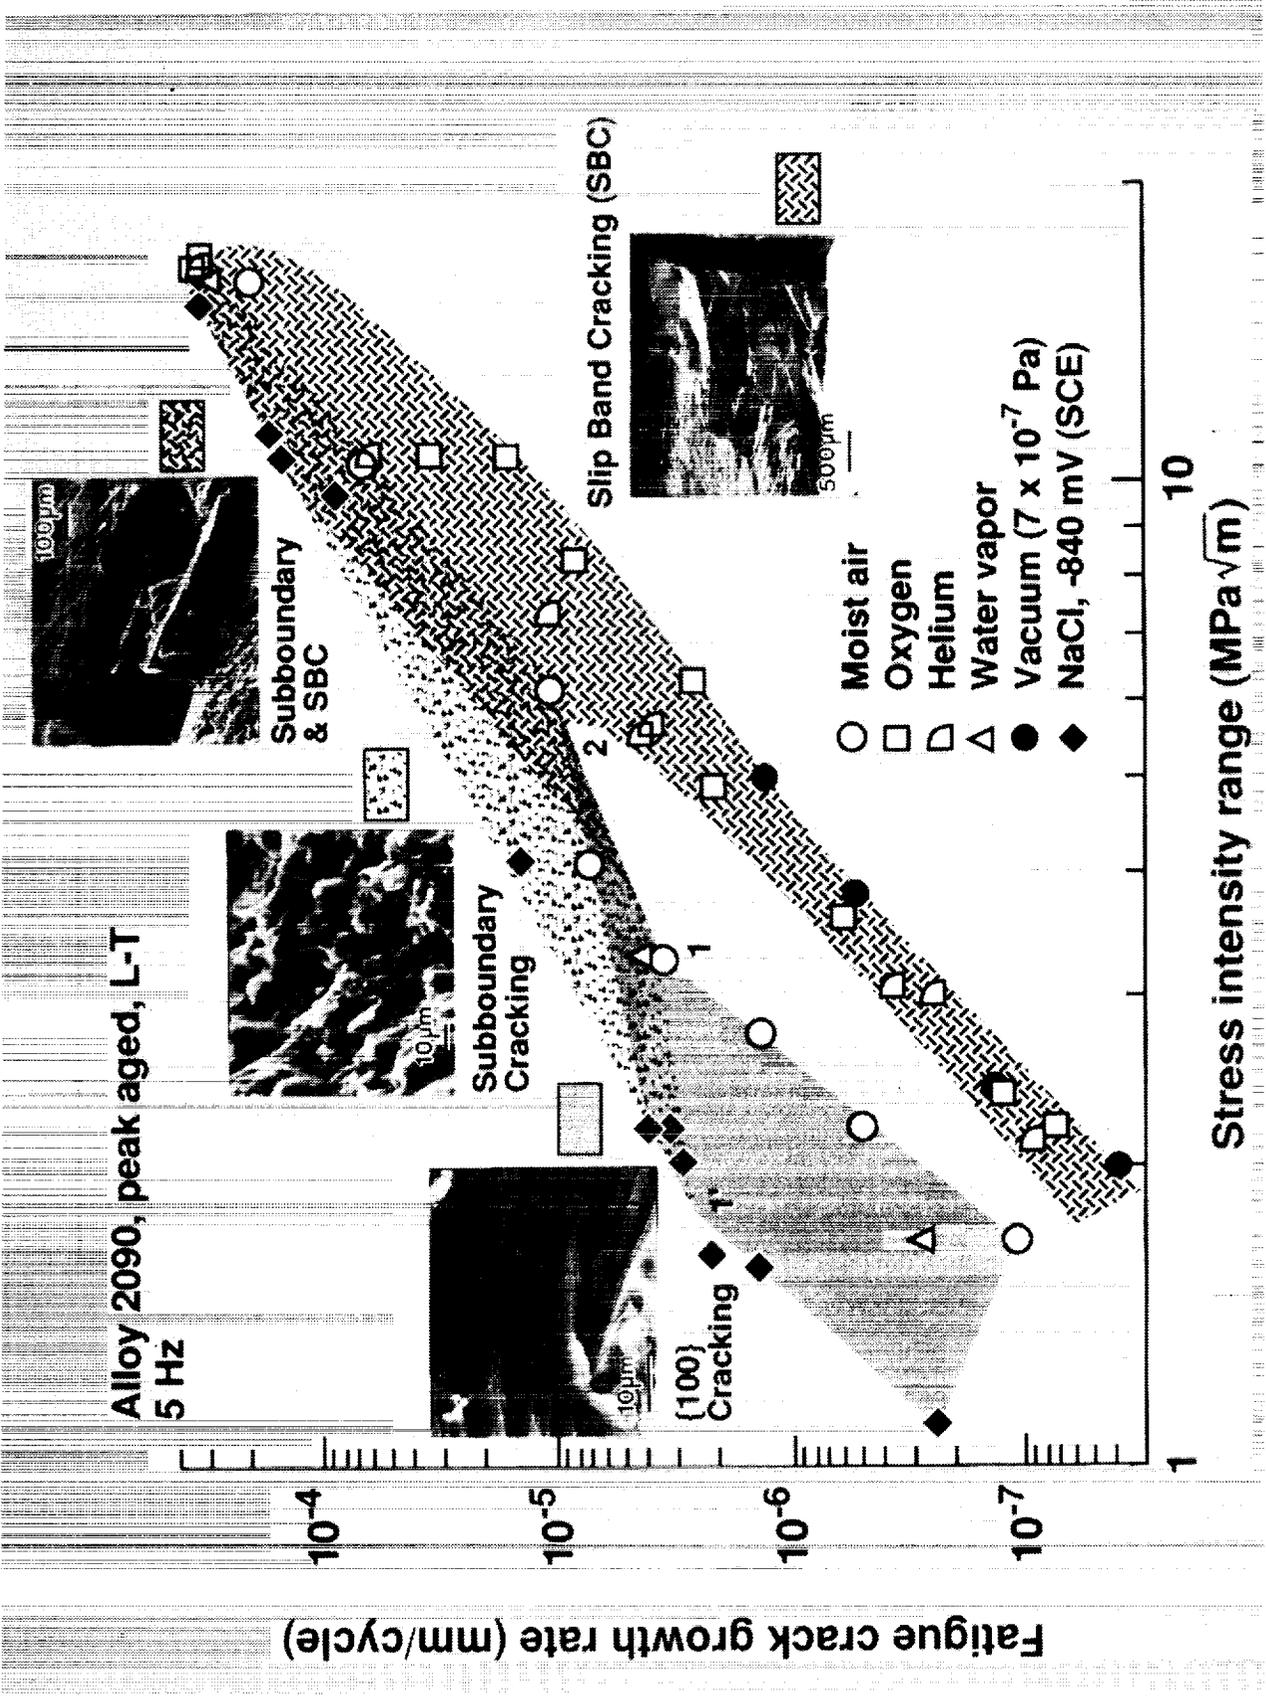
Figure 12 A correlation of peak aged alloy 2090 (L-T) fatigue crack growth kinetics from Part I<sup>(1)</sup>, and microscopic fracture paths for inert environments (vacuum, helium, and oxygen) and hydrogen producing environments (water vapor, moist air and aqueous NaCl) at constant  $K_{max}$ .

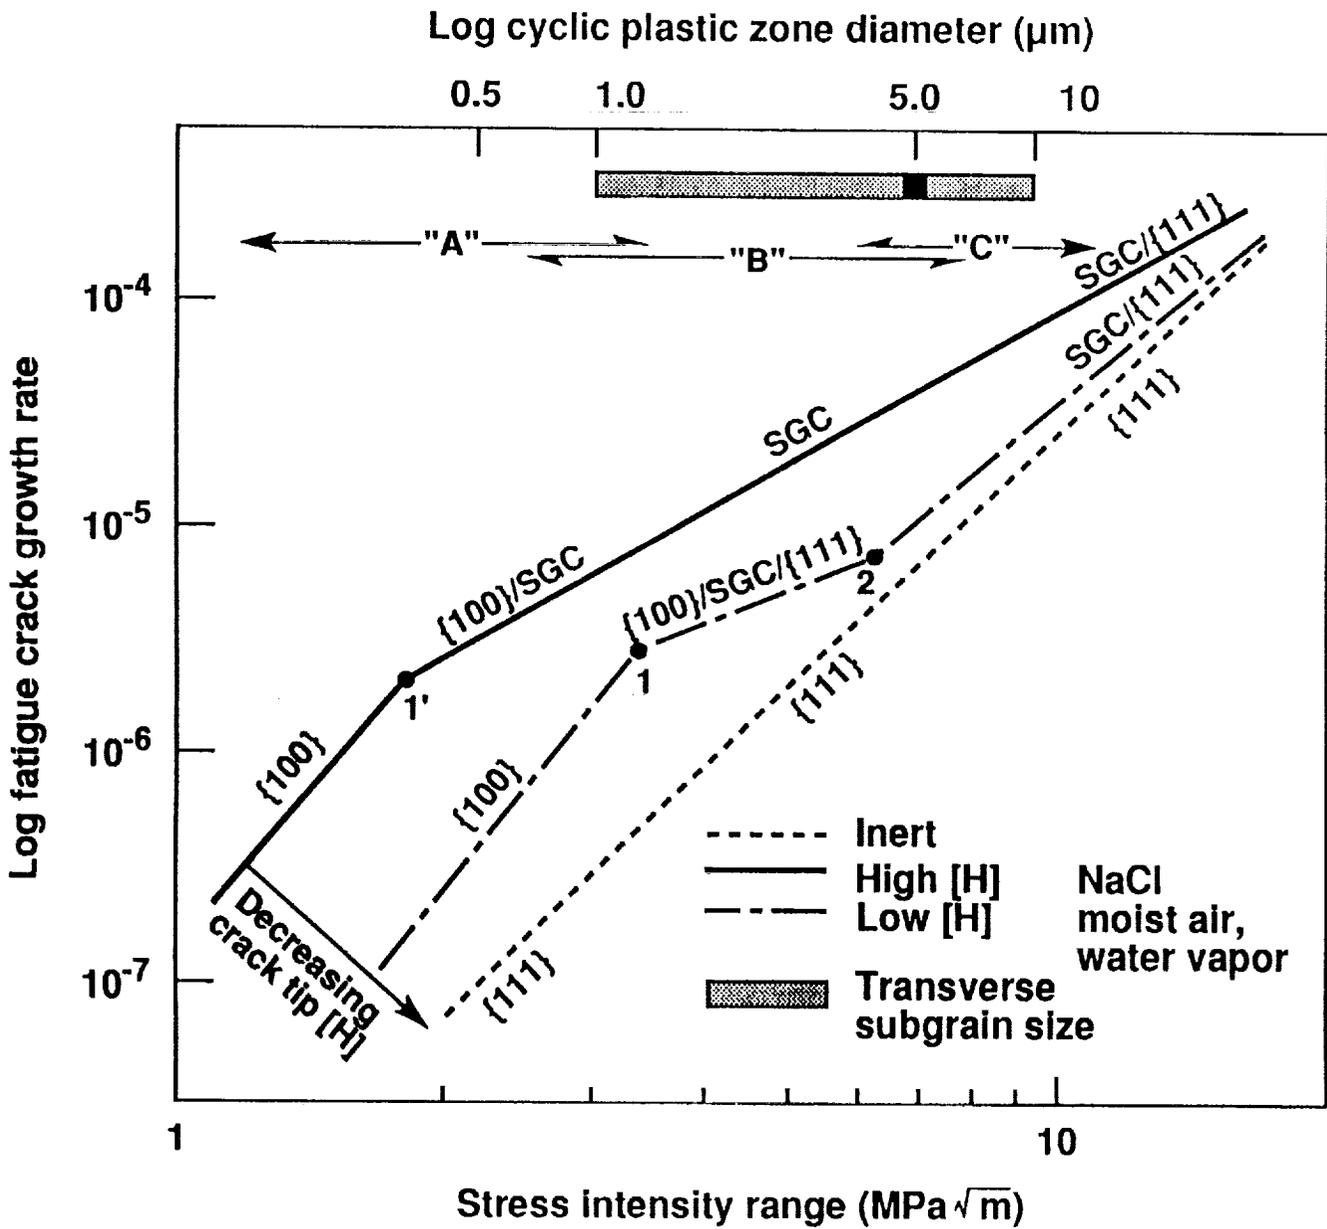
**Figure 13** A schematic of the effects of subgrain size and crack tip hydrogen concentration, [H], on the FCG characteristics of alloy 2090. (High [H] corresponds to anodic NaCl and low [H] to moist air.)
